Burying Ground Preservation Group, Inc.

August 26, 2019

Final Report: DeLancey Burying Ground, Mamaroneck, New York:
Survey, Clean, Record & Restore

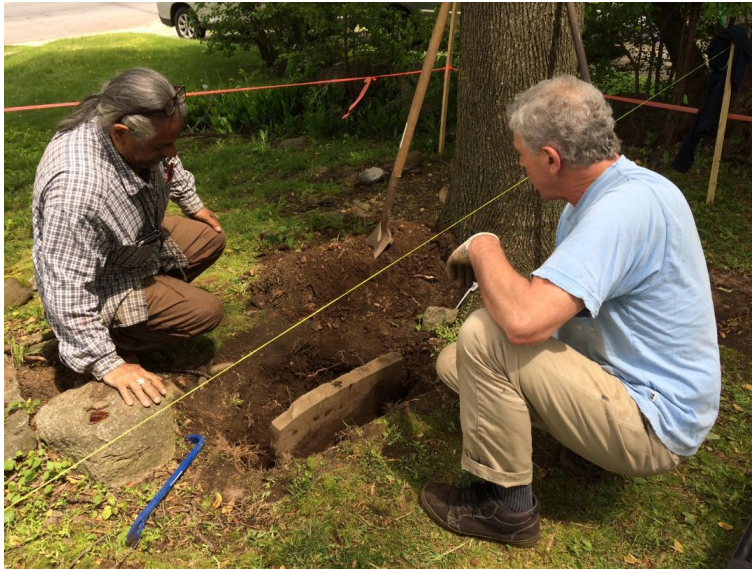
Examining the buried base of the Susannah DeLancey headstone, one of five fragments requiring cleaning and reassembly and reattaching with pins and structural adhesives.

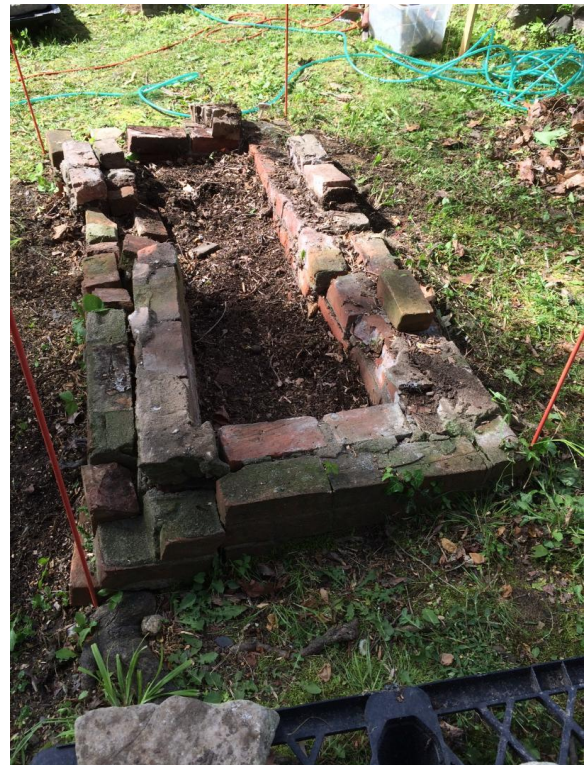
The box tomb of Thomas J. and Mary Jane DeLancey was in a state of total collapse. A large tree root undermined the brickwork supporting the marble tablet, which was broken into six pieces. Repair required temporary relocation of the marble fragments, removal of the tree root and reconstruction of the brick base, and reassembling and attaching of the inscribed marble tablet. Thin marble tiles were attached to one end of the base to provide support for the smaller fragments and cover the opening into the base.

The brick base of the box tomb of Thomas J. and Mary Jane DeLancey is shown exposed, after temporary removal of marble tablet fragments. A large tree root that caused the deterioration of the brickwork and undermined the future integrity of the tomb was removed; the bricks were recycled and the base was rebuilt; and the marble tablet was reassembled and reattached.

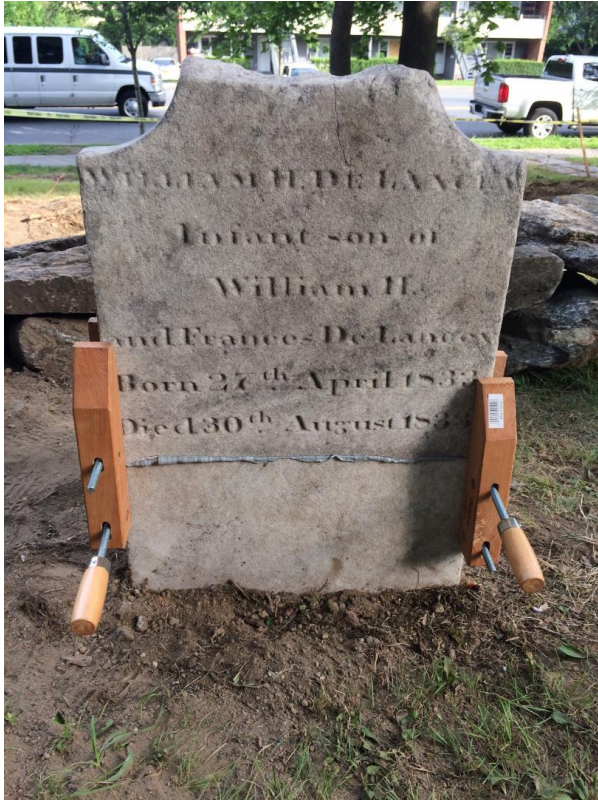
The headstone of William H. DeLancey, which was found on the ground broken into two pieces and dislocated from its place within the site, was cleaned of soil and bio-growth, and reset after reattaching with structural adhesives.

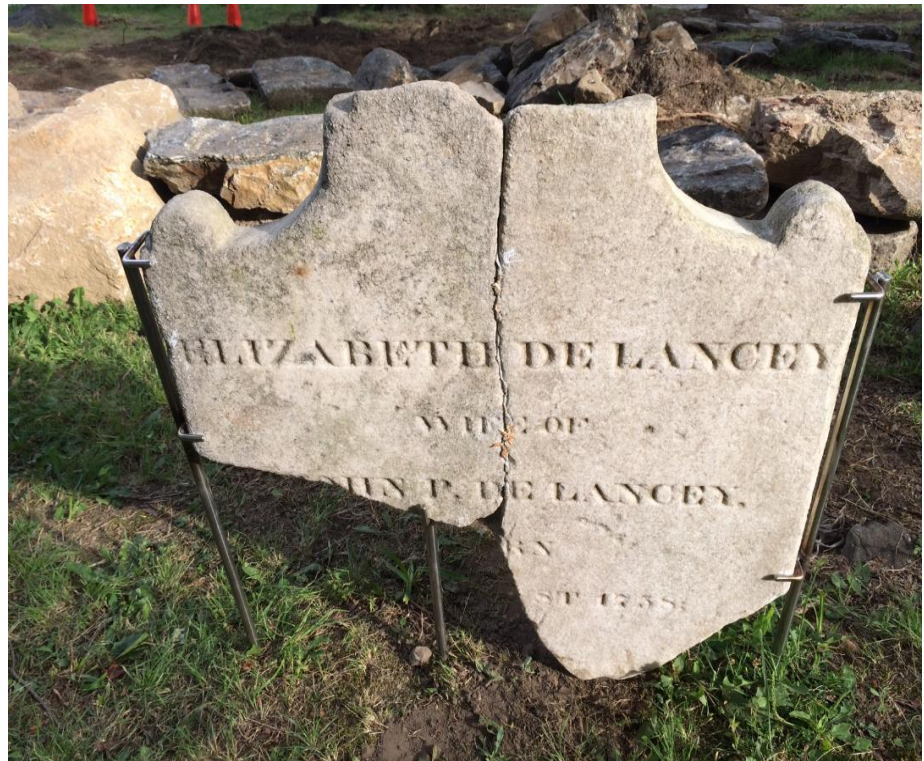
Only two fragments of the Elizabeth DeLancey headstone survived; fortunately, they preserve an inscription worth restoring. The pieces were attached with pins and structural adhesives and a special armature of steel rods with welded clamps was designed and fabricated in order to support the stone after resetting in the ground.
