**Shelter Island Presbyterian  
Church:  
North & South Burying  
Grounds**

*Conditions Survey &  
Recommendations for Treatment*

**Shelter Island Chapter NSDAR  
Cemetery Restoration Project**

*Zachary N. Studenroth  
Historic Preservation Consultant  
April 2012*

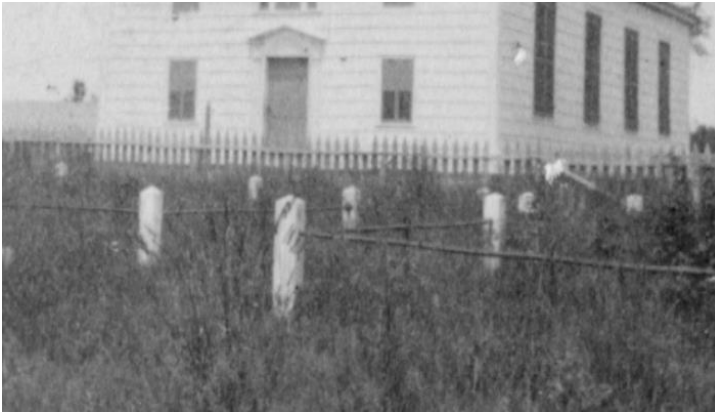
A second system of fencing survives at the south side of the North Burying Ground facing Rte. 114, to the left (west) of the church. This is a remnant of the Victorian era, cast iron border fencing that evidently stretched further to the west before the creation of the parking lot. The South Burying Ground now retains only a chain link fence along its north boundary facing Rte. 114. The remaining three sides are bordered by hedgerows. The date of installation of the chain link fence is undocumented, although it appears to date from the mid-20<sup>th</sup> century. An historic photograph of the late 19<sup>th</sup> century (below) reveals that a picket fence once stretched along the north side of the site, although it cannot be determined if the posts were of stone (like that of the internal system in the North Burying Ground) or of wood.

It is recommended that the historical photographs of the North and South Burying Grounds be studied further in relation to the present day use of each site, taking into consideration circulation patterns and other factors. A plan can then be formulated for the restoration or reconstruction of fencing along the boundary lines and within the sites. Fragments of existing historical fence should be preserved and restored. These include the length of Victorian era iron fence that survives to the west of the church (a portion of which appears in early views), as well as the stone piers in the North Burying Ground (which once supported a picket fence and were re-purposed later to support iron chains). Lacking now is historic fence along the north boundary of the South Burying Ground, which appears to have been a combination of decorative iron Victorian fence (at the west end/entrance) and wooden picket fence.

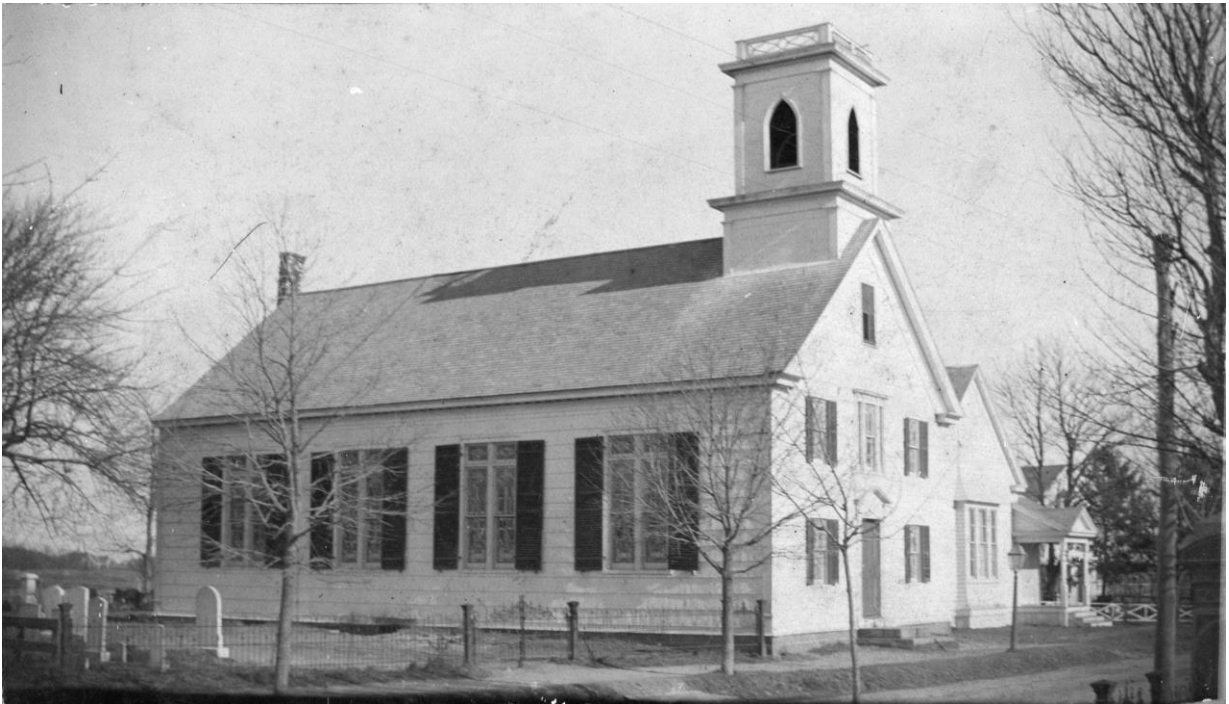
Another historic photograph (below) suggests that at least a portion of the South Burying Ground preserved a section of decorative iron Victorian fencing like that preserved on the north side; a small section of its iron gate may be seen in the lower right. It, too, was removed and replaced with the chain link fencing seen today.

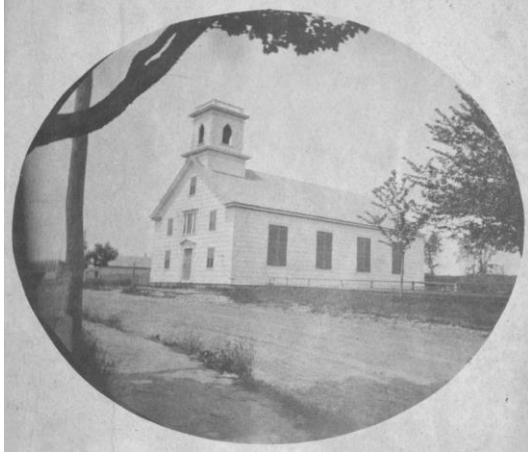
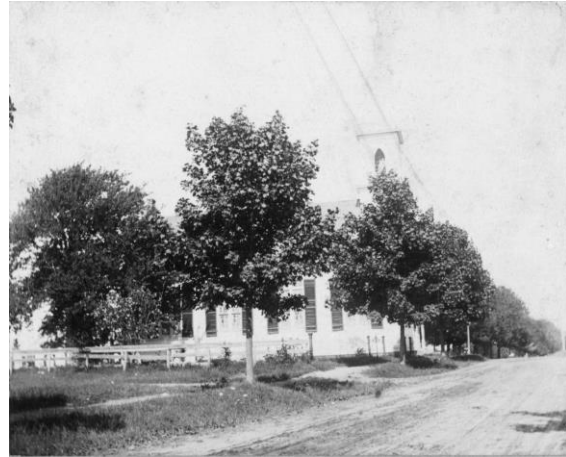
Early views also identify board fences that stretched to the east and west of the church. This common form of fence is often used along the side and rear yards of properties and is combined with “better” types that are reserved for the front. Such seems to be the case at the church property, as seen in these two historical views.
