Burying Ground Preservation Group, Inc.

VAN SCOY BURYING GROUND, EAST HAMPTON, NY:

CONDITIONS ASSESSMENT & CONSERVATION TREATMENT REPORT

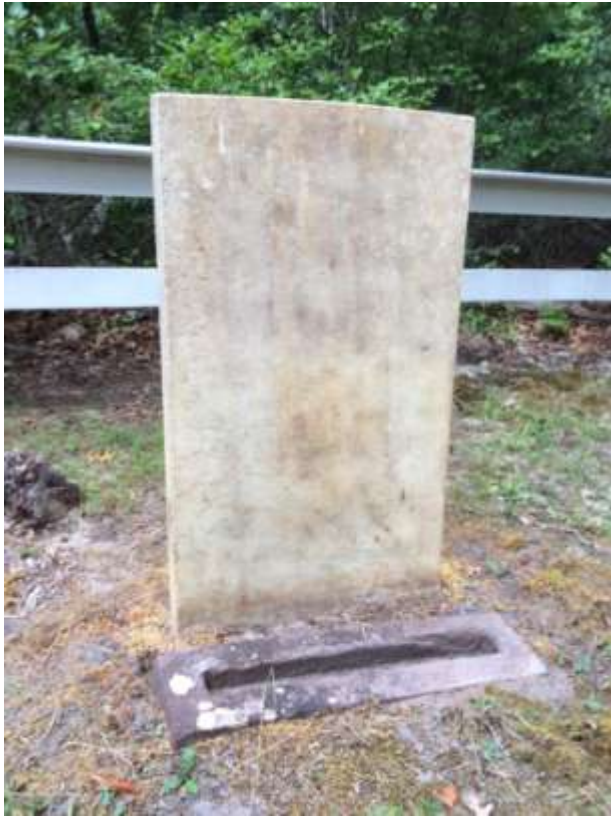
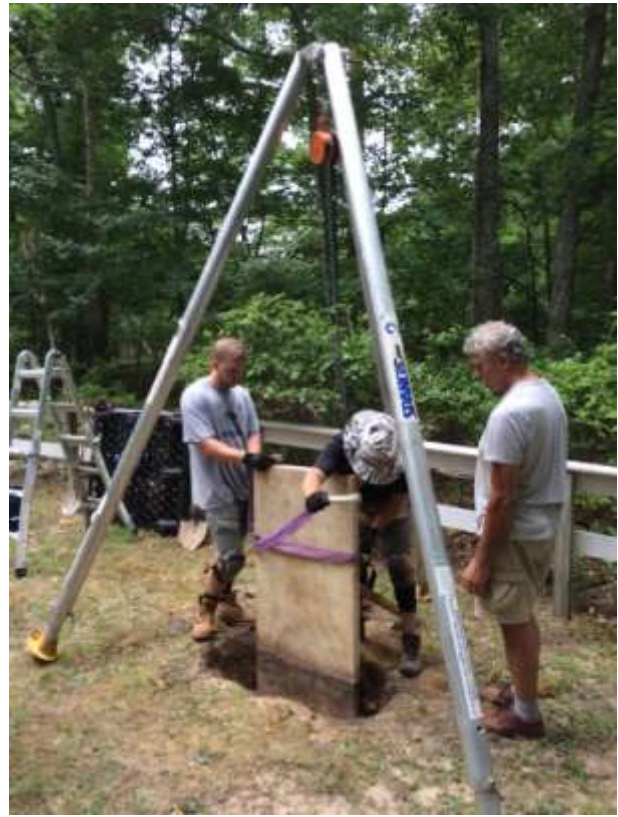
Rhoda B. Van Scoy

A tall, marble tablet that was dislocated from its brownstone base and reset into the ground. Lacking adequate support due to its size and weight, the leaning tablet was vulnerable to falling and breaking. Soiling and bio-growth impaired legibility.

Tablet dislocated from brownstone base (left); hoisting marble tablet after resetting base below grade (right).

Treatment included cleaning the tablet with water and detergent and treating with an antimicrobial agent; excavating a hole deep enough to reset the base below grade; hoisting the headstone

with a heavy duty tripod to facilitate repositioning and leveling; lowering and fastening the tablet to the base; and backfilling and cleaning.

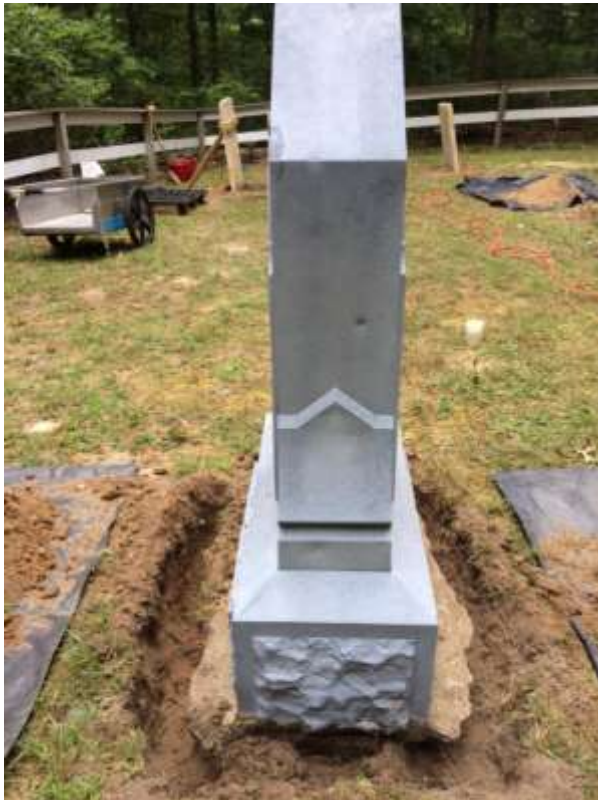
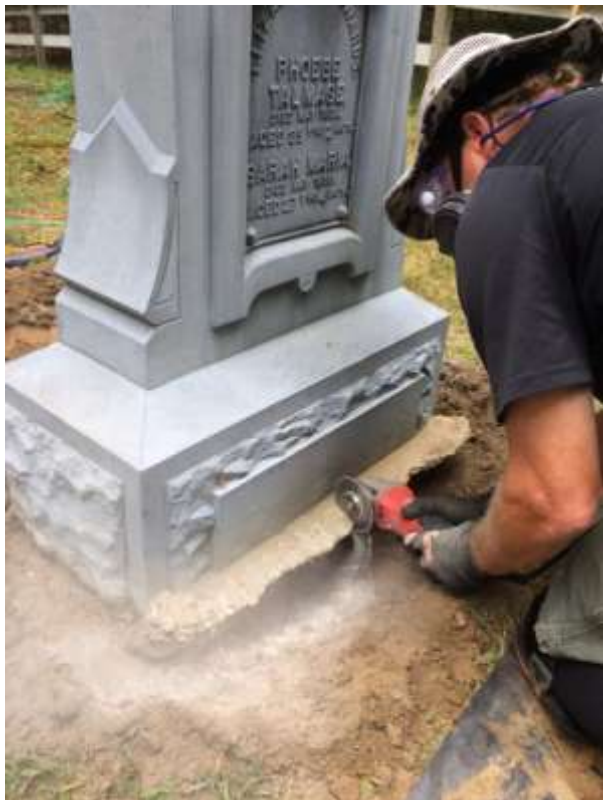
Edwards Monument

This two-sided monument, cast in zinc, bears the records of five Edwards family members. Marketed as “white bronze” beginning in the 1870s, this novel material lost popularity in the 1920s and is consequently unusual today, especially in small family burying grounds. Although durable, the hollow zinc monument had tilted, prompting a previous repair – poured concrete – to prevent further movement. The concrete adhered to the metal, however, and because of its weight and hardness actually threatened to crack the monument.

Exposed concrete repairs at base (left); sawing concrete from base of monument before resetting (right).

Treatment required exposing, cutting and chiseling the concrete, leaving the original surface of the metal revealed and undamaged. The monument was then reset on a level base of small stones and sand.

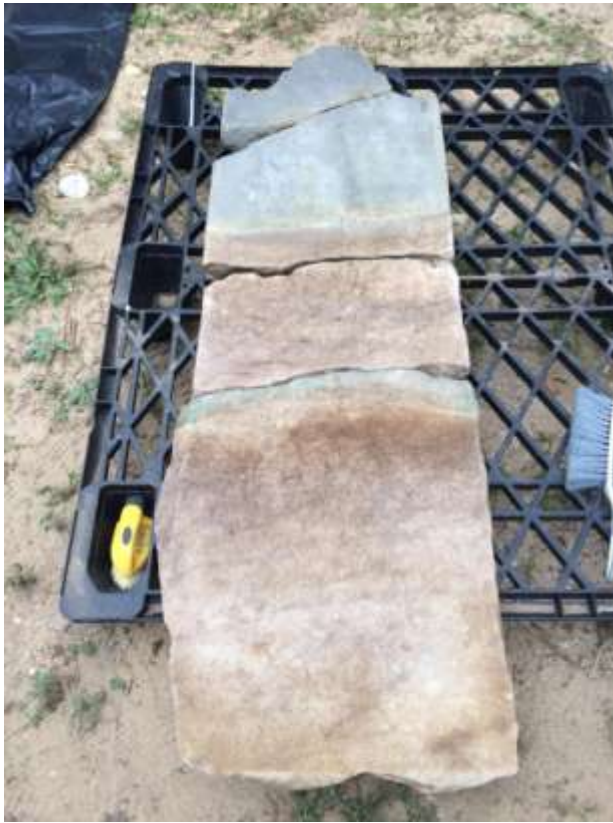
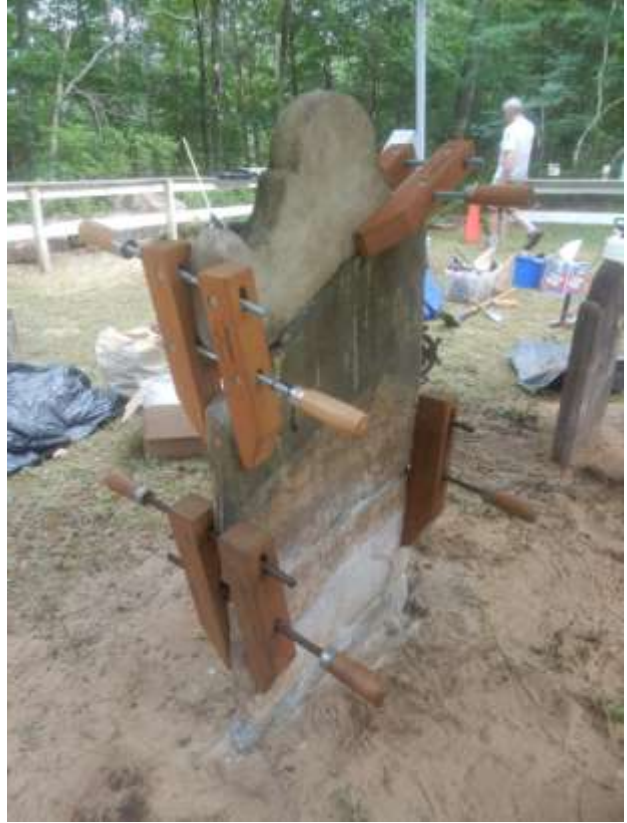
In addition to being broken into four pieces, the Isaac Van Scoy tablet was a focus of the project because of Van Scoy’s distinction as a patriot in the American Revolution. He and Isaac Van Scoy, Jr., both signed the Association in East Hampton on May 5, 1775, signifying they were capable of bearing arms (*The Refugees of 1776 from Long Island to Connecticut*, Mather, 1913, p. 1062). The headstone fragments had been reset in the ground and exhibited varying degrees of soiling, bio-growth and stone loss.

Reassembled pieces before repairs (left); pieces pinned, reattached with structural adhesive and braced (right).

Treatment included removing the stone pieces from the ground, reassembling and cleaning, prior to resetting and reattaching with structural pins and adhesives. The cracks were filled and one large area of stone loss infilled with white mortar. Due to the surface discoloration of the marble, which will gradually whiten over time, the fills were chosen to match the original stone color. Repairs that remain visible become part of the story and history of a monument over time.

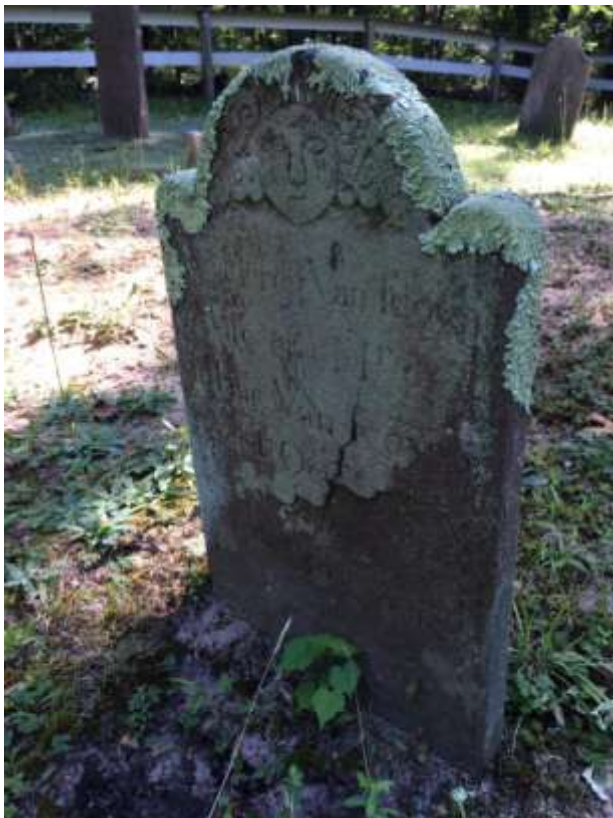
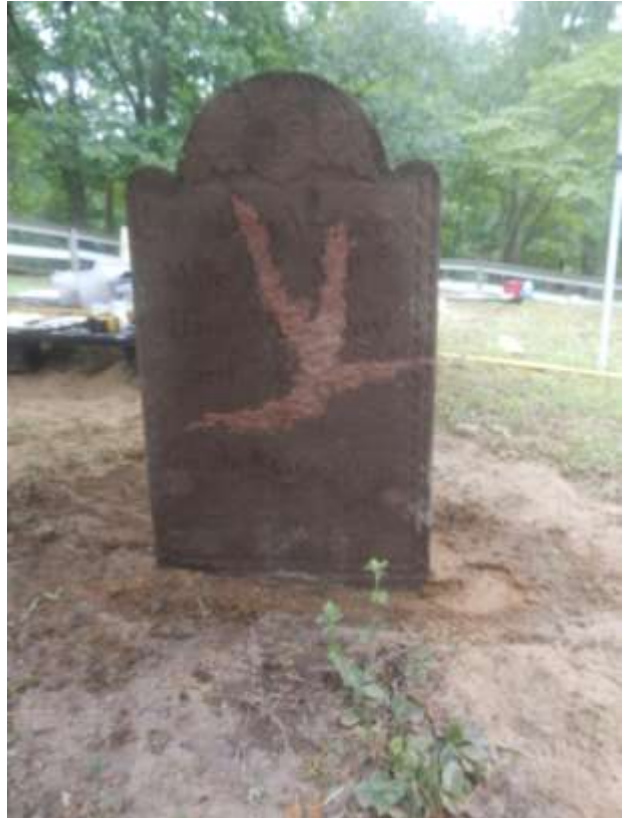
Mercy Van Scoy

The wife of Isaac Van Scoy, Mercy’s headstone takes its place next to Isaac; unlike his marble headstone, however, Mercy’s was carved in brownstone and suffered from delamination, a typical form of deterioration for this layered, sedimentary rock. The freeze-thaw action of water penetrating the stone’s inscription can produce internal voids and visible surface cracks, as in this case. Fortunately, actual stone loss was minimal.

Brownstone tablet encrusted with lichen before cleaning (left); repair in progress with liquid grout injected (right).

Treatment involved careful removal of lichens and biogrowth which were pronounced on this stone. Drilling and injecting liquid grout to fill the hollow void behind the inscription was then done, followed by cosmetic fills at each of the drill marks. While the outer layer of brownstone still projects beyond the original surface of the stone, it is now stable and protected against freeze-thaw cycles.
